**ARKANSAS DEPARTMENT OF ENVIRONMENTAL QUALITY
P. O. BOX 8913, LITTLE ROCK, AR 72219-8913**

COMPLAINT REPORT

**Arkansas Department of Environmental Quality (ADEQ)
Official Photograph Sheet**

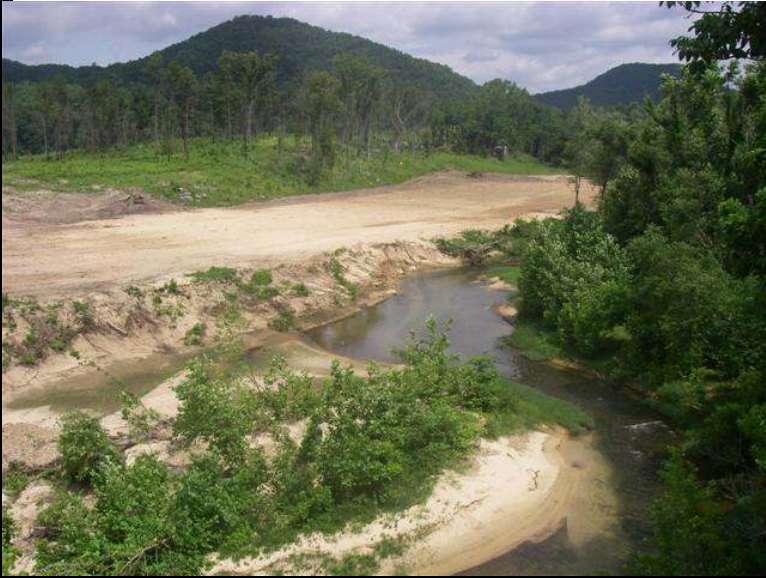
Location:		B&H Resources, LLC., Izard County					
Photographer:		Tony Morris			Witness:		
Photo #	1	Of	6		Date:	06/13/08	Time: 10:21
Description:		An over view of a portion of the recently deforested 249 acre mine site with Mill Creek in the foreground.

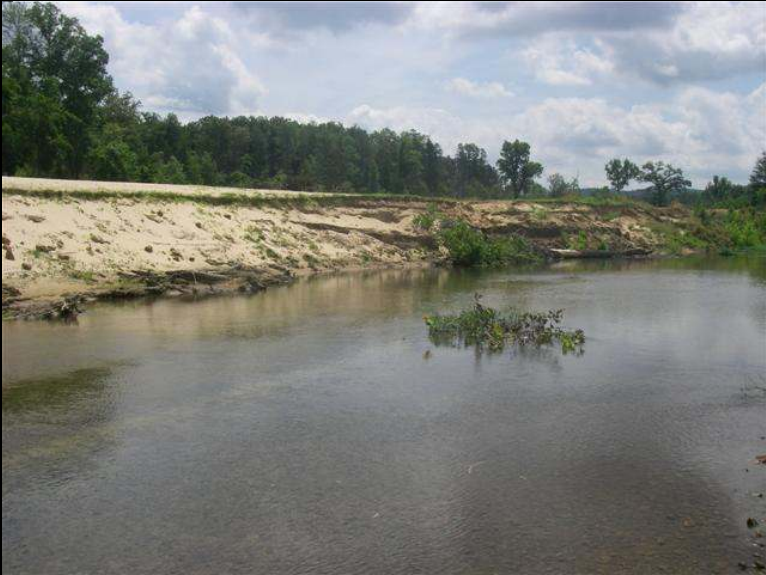
Photographer:		Tony Morris			Witness:		
Photo #	2	Of	6		Date:	06/13/08	Time: 10:38
Description:		A barren stream bank on Mill Creek in the proposed mine site.

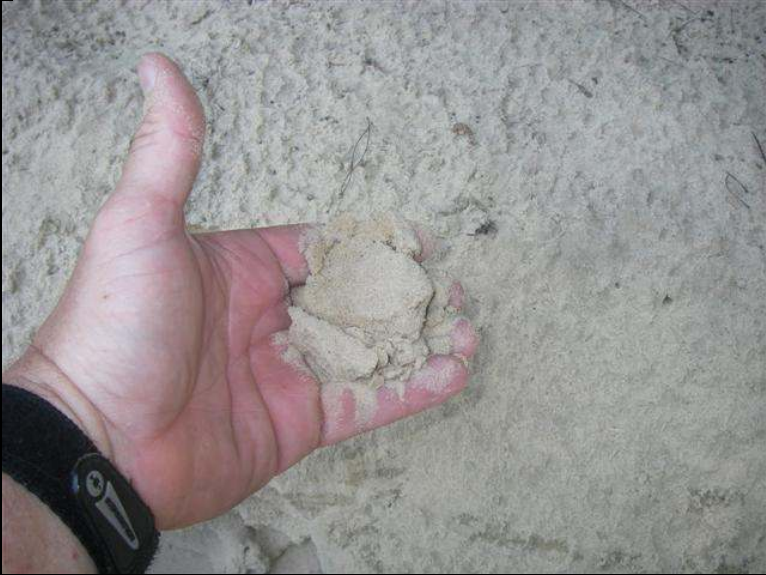
Location:		B&H Resources, LLC., Izard County					
Photographer:		Tony Morris			Witness:		
Photo #	3	Of	6		Date:	06/13/08	Time: 11:20
Description:		The erosion prone alluvial sediment on the banks of Mill Creek in the mine site.

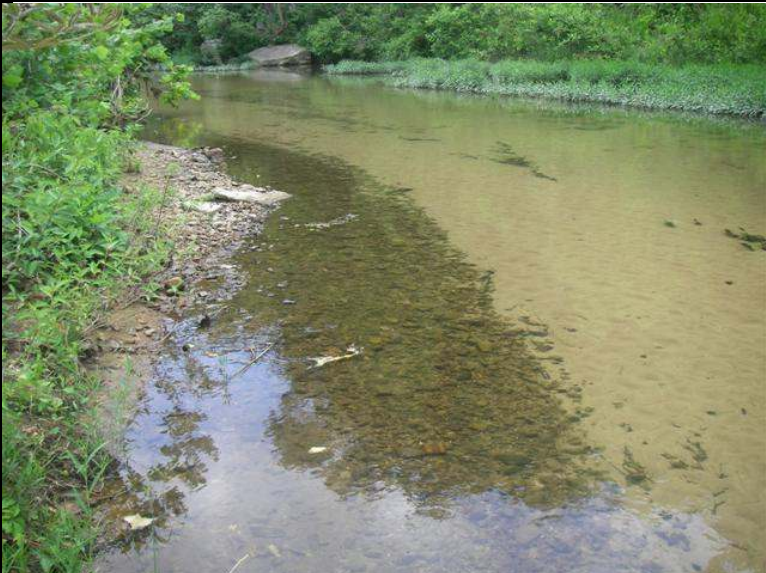
According to adjacent land owners, the company began clear cutting timber on the mine site, including the riparian areas, in January 2008. Clearing of stumps and residual vegetation began in April of 2008. At the time of this investigation there was equipment parked near the confluence of Peorogue Creek with Mill Creek and signs of recent dozer operation on the stream banks. As a result of the removal of the riparian vegetation, massive bank erosion is occurring along Mill Creek over an approximately one mile reach within the proposed mine site. No effort is being made to control erosion and as a result, the gravel substrate is smothered in sediment and the pools are filled with sediment through the length of stream on the mine site to below the confluence with Piney Creek a distance approaching 2 miles. The massive sediment loss from the mine site to area streams is causing a significant alteration of habitat.

Photographer:		Tony Morris			Witness:		
Photo #	4	Of	6		Date:	06/13/08	Time: 11:39
Description:		The gravel substrate (darker material) of Mill Creek with recently deposited sediment at a location just down stream of the mine site western property line.

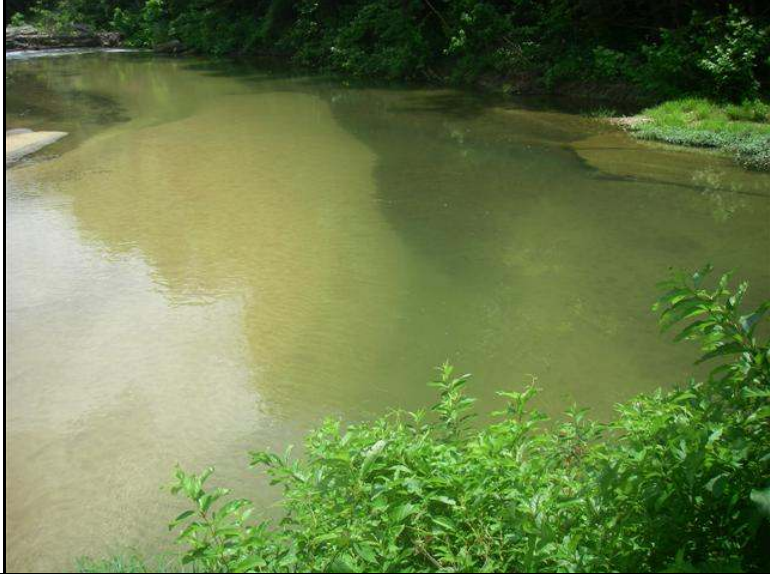
Location:		B&H Resources, LLC., Izard County						
Photographer:		Tony Morris			Witness:			
Photo #	5	Of	6		Date:	06/13/08	Time:	12:10
Description:		The confluence of Mill Creek (Left) with Piney Creek (Right) with the lighter colored sediment plume originating from the mine site visible.
